Vanguard Applications Ware Release 6.1.T14A Advisory Notice

Introduction

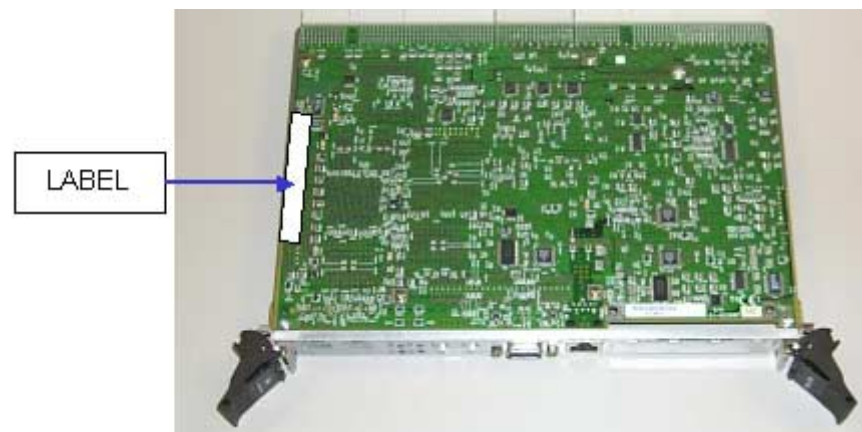
Figure 1. Part Number Label

The Vanguard 7300 Series MCP750 (part number 75836G02) system cards are supported by software releases 6.1.T14A and greater. If you have a part number 75836G02 system card and are running older versions of release 6.1, a new 6.1 software patch is required (6.1.T14A). The system cards have a different revision PCI-PCI bridge than previous system cards (part number 75836G01). The new system cards are not being recognized by software older than 6.1.T14A. Software patch 6.1.T14A must be installed when using part number 75836G02.

Figure 1 shows the revision label, located on the side of the unit.
